PORTENCROSS CASTLE;  
ARCHAEOLOGICAL EVALUATION  
DATA STRUCTURE REPORT

PROJECT 2597

carried out  
on behalf of  
Friends of Portencross Castle Ltd

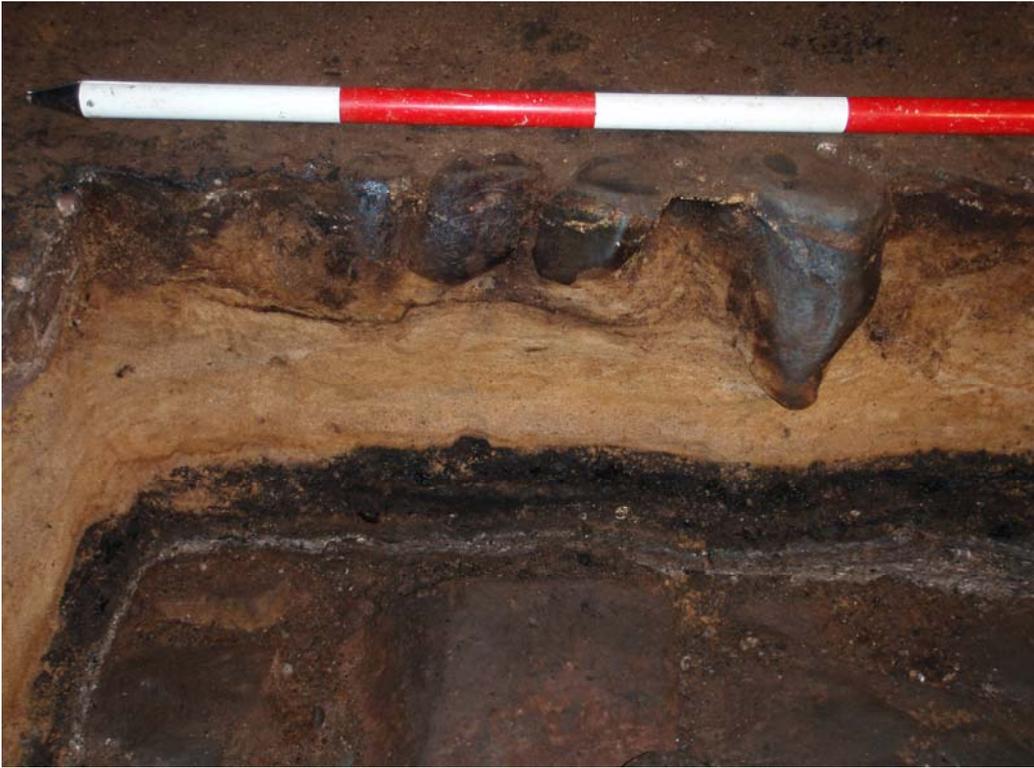
Figure X Part of North-west facing section of trench, north end

At the bottom of the evaluation trench bedrock was noted, which had a deposit of gravel and pebbles (026) that lay above larger sub-rounded stones (not excavated). These two deposits are very likely to be the original levelling layer within the castle basement and were used to fill the spaces between the uneven surfaces of the bedrock. Above this, and partially set into it, was a deposit of squared and rectangular stones (025) that are probably the remains of the original floor. This surface was quite rough and the stones did not appear to have been dressed, making the floor surface uneven. The surface may have been levelled naturally by deposits of what appears to be domestic or industrial debris (024). This deposit comprised heavily compacted white/light-grey crushed lime or ash. A deposit of black or dark brown silt (016) that had inclusions of small rounded stones and sea shells lay above the crushed lime/ash. This deposit was quite loosely compacted and would not have been robust enough to have been a floor surface. The inclusions of sea shell and the general composition of this deposit suggest that it most likely represents material that built up during a period of abandonment of the castle. A sherd of modern white-glazed pottery (SF7) was recovered from this layer, and was most likely deposited during later renovations to the basement floor.

Above the probable abandonment layer (016) at the south end of the trench was a very heavily compacted deposit of black silt (015) that had inclusions of charcoal, clinker, coal and broken sea shells, and smelled quite strongly of hydrocarbons. This is a modern deposit and may relate to the in-filling/destruction of the drainage culvert or to preparing the floor prior to the laying-down of the cobbles and flagstones. However, its actual purpose is presently unknown. Two distinct layers of sand lay above (015). The earlier of these was fine and yellow in colour (014) and closely resembles modern builder's sand, and the more recently deposited layer was coarse-grained yellow/brown sand (013) that appeared similar in composition to the sand at the Old Harbour at Portencross. Pieces of modern nylon rope and plastic (SF5) were recovered from the coarse sand deposit (013). Both of these deposits appear to be of relatively modern date and are probably contemporary with the use of the castle basement for fishing-related activities.

### 7.1 Basement (Figure 4 & X)

The evaluation in the castle basement established that there at least two phases of flooring in this area, the earliest of which is a rough stone floor about 0.45 m below the level of the existing flagstone and cobble floor. The entire level of this earlier floor had to be built-up using a foundation layer of large, rounded stones capped with a deposit of silty gravel. The squared stones that comprise the floor were set into the silty gravel, and this uneven surface was levelled by the addition of a compacted layer of domestic or industrial debris. An upper deposit of black silt is likely to date to the period when the castle was abandoned.

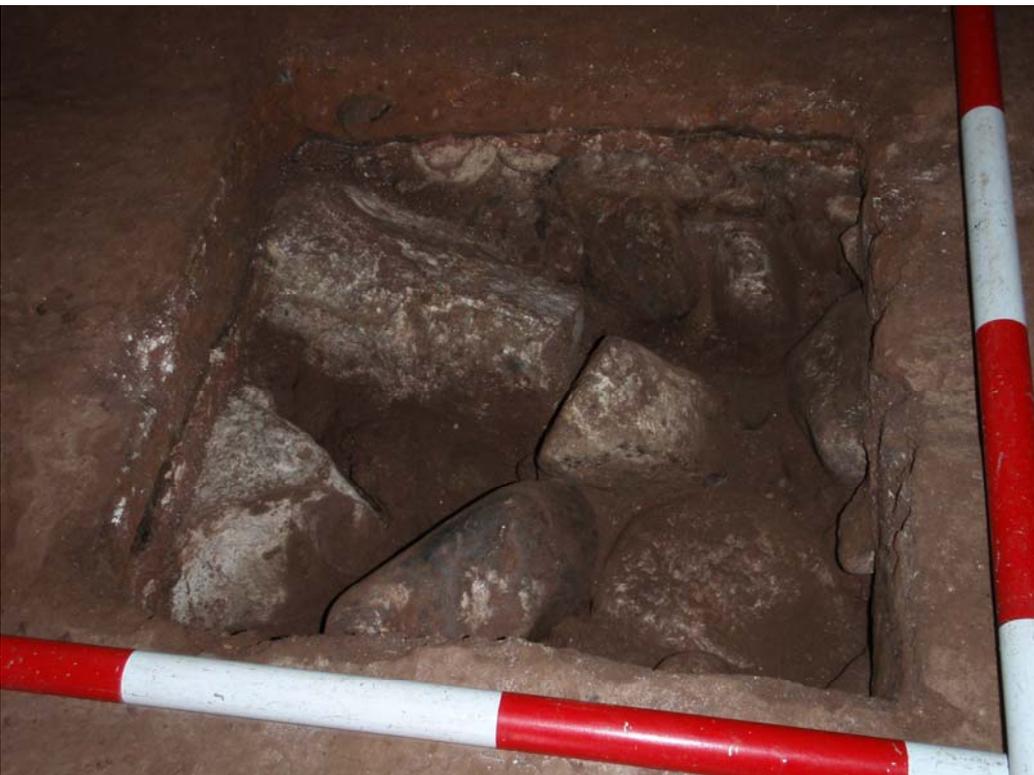
Figure X Post-excavation view of Test Pit 1

The two test pits in the Great Hall showed that the floor above the barrel-vaulting in the basement was levelled using an infill of rounded and squared stones (011) and gravel (009). A very thin deposit of black silt (008) with inclusions of pea gravel, charcoal and lime mortar above the rubble infill is probably a cushioning or levelling layer for the actual floor surface. In test-pit 1, additional evidence for levelling is provided by a thin layer of red/brown silt (012). A layer of heavily compacted orange/brown clay (007) with inclusions of small rounded stones is likely to be the floor surface in the Great Hall. At the time of the evaluation, a heavily compacted deposit of mid-brown silt (006) covered the floor surface of the Great Hall. Patches of windblown sand, thin slivers of wood and pieces of lime mortar, presumably having fallen from the ceiling and walls, were included in this layer and a copper nail (SF1) was recovered from it. The pieces of wood were included in an environmental sample and may be the subject of future analysis.

### 7.2 Great Hall (Figure 5 & X)

The test pits in the Great Hall showed that the gaps at the north and south walls between the walls and the barrel-vaulted ceiling of the basement were infilled using gravel, broken masonry blocks and rounded stones. The surface was levelled using what appears to be raked-out material and domestic debris, and a fairly thick orange/brown clay floor was laid down on top. No other floor surface was found in the Great Hall, although it is possible that flagstones or wood comprised the actual walking surface. Thin, fragmentary pieces of wood were found in the existing floor deposit, but there is no indication that they are associated with an earlier floor surface.
